Miracote MPC Decks the Walls (and floors) at Park Shore Retirement Community

Submitted by: Steve Cottle / Industrial Coatings and Sealants, Inc.
Contractor: Buzz Manchester / Bedrock Coating & Contracting, Black Diamond, WA
Products Used: Repair Mortar Type I, Membrane A, Miracote MPC
Project: Park Shore, Madison Park, WA

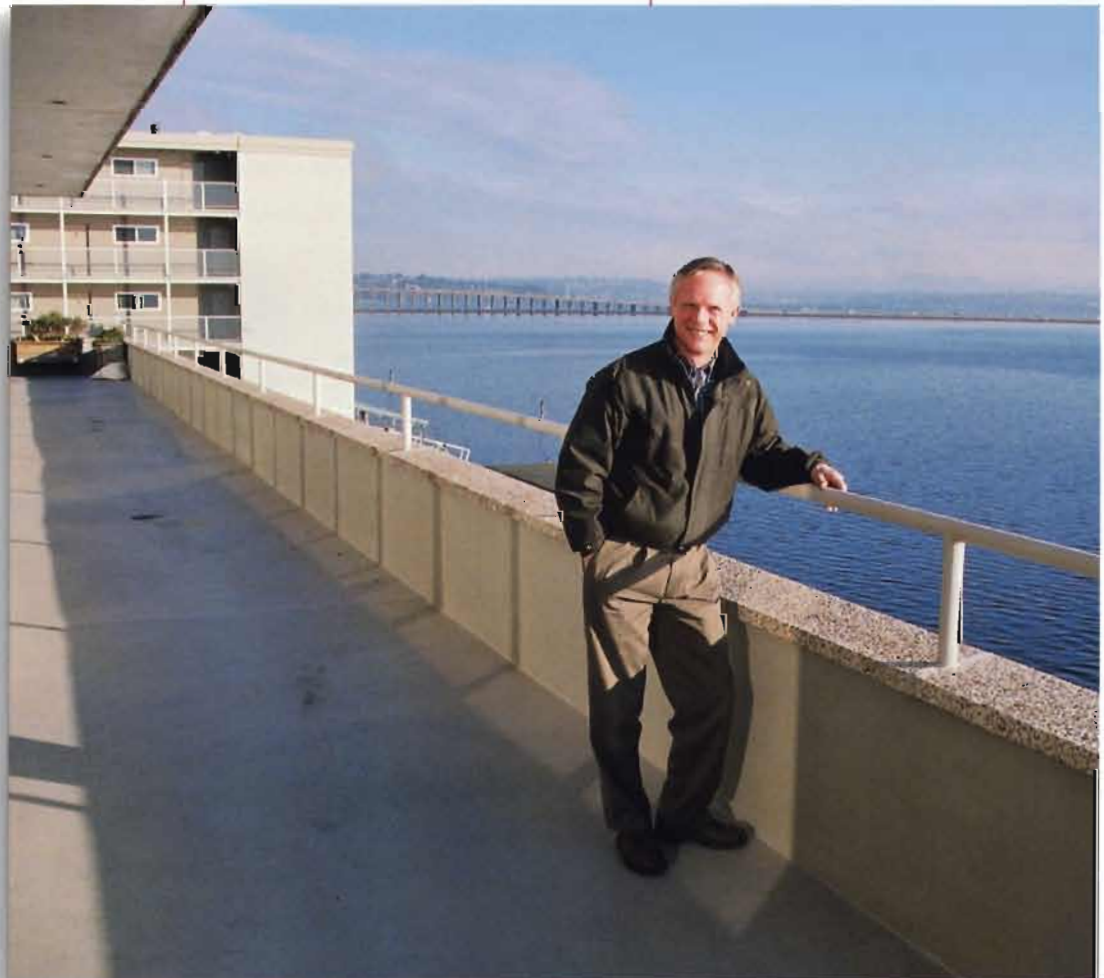
The wraparound decks and walkways comprised approximately 20,000 square feet of the facility's original concrete slab that was covered with a waterproof layer of bitumen

membrane topped with a 2.5 inch concrete topping slab that had deteriorated.

Due to environmental thermal cycling conditions, cracks had formed in the topping slab and the cracks had progressively deteriorated. The cracks provided an opening through which black, unsightly, oozing bitumen out-migrated, literally gumming up the walkways.

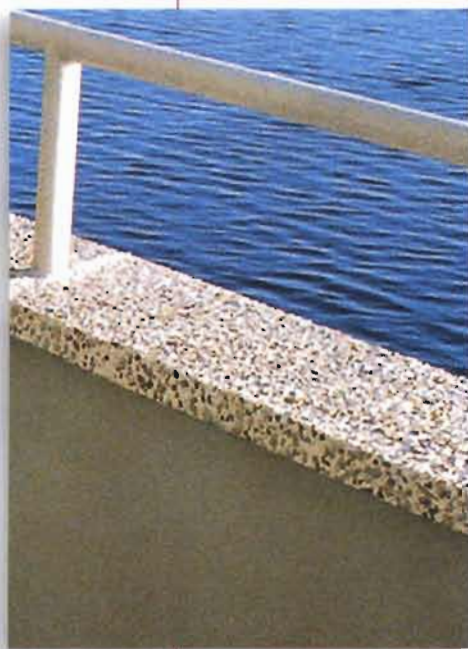
To solve this issue, a cove base was created with Miracote's Repair Mortar Type I. This two-component polymer modified resurfacing

compound was troweled to form a 4" cove base with approximately 150 lineal feet placed per day.
